Debris/Ice/TPS Assessment And Photographic Analysis For Shuttle Mission STS-35

Gregory N. Katnik
NASA/Kennedy Space Center

DEBRIS/ICE/TPS ASSESSMENT
AND
PHOTOGRAPHIC ANALYSIS
OF
SHUTTLE MISSION STS-35

December 2, 1990

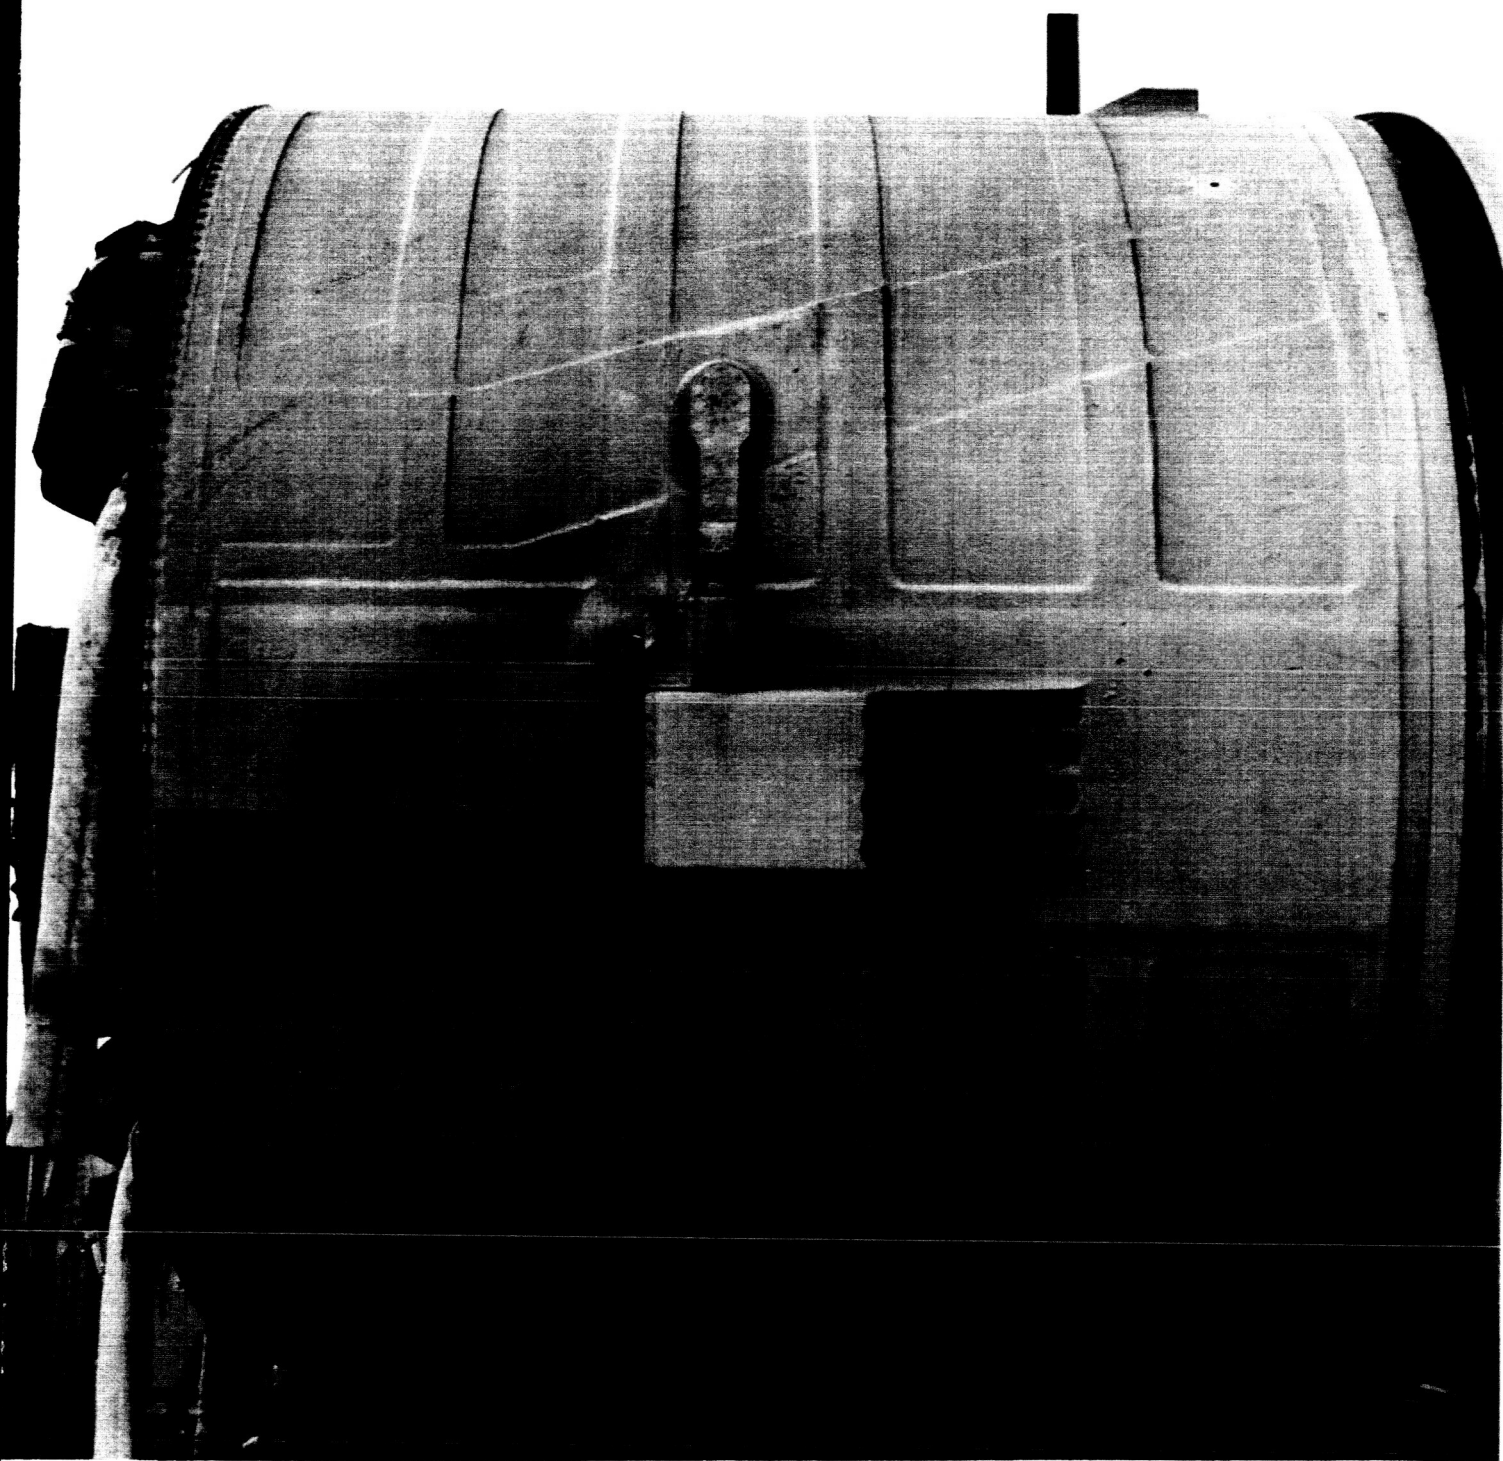
Post flight condition of the RH forward skirt. There were no MSA-2 debonds or areas of missing TPS. The parachute release ordnance had not fired at splashdown (orange containers).

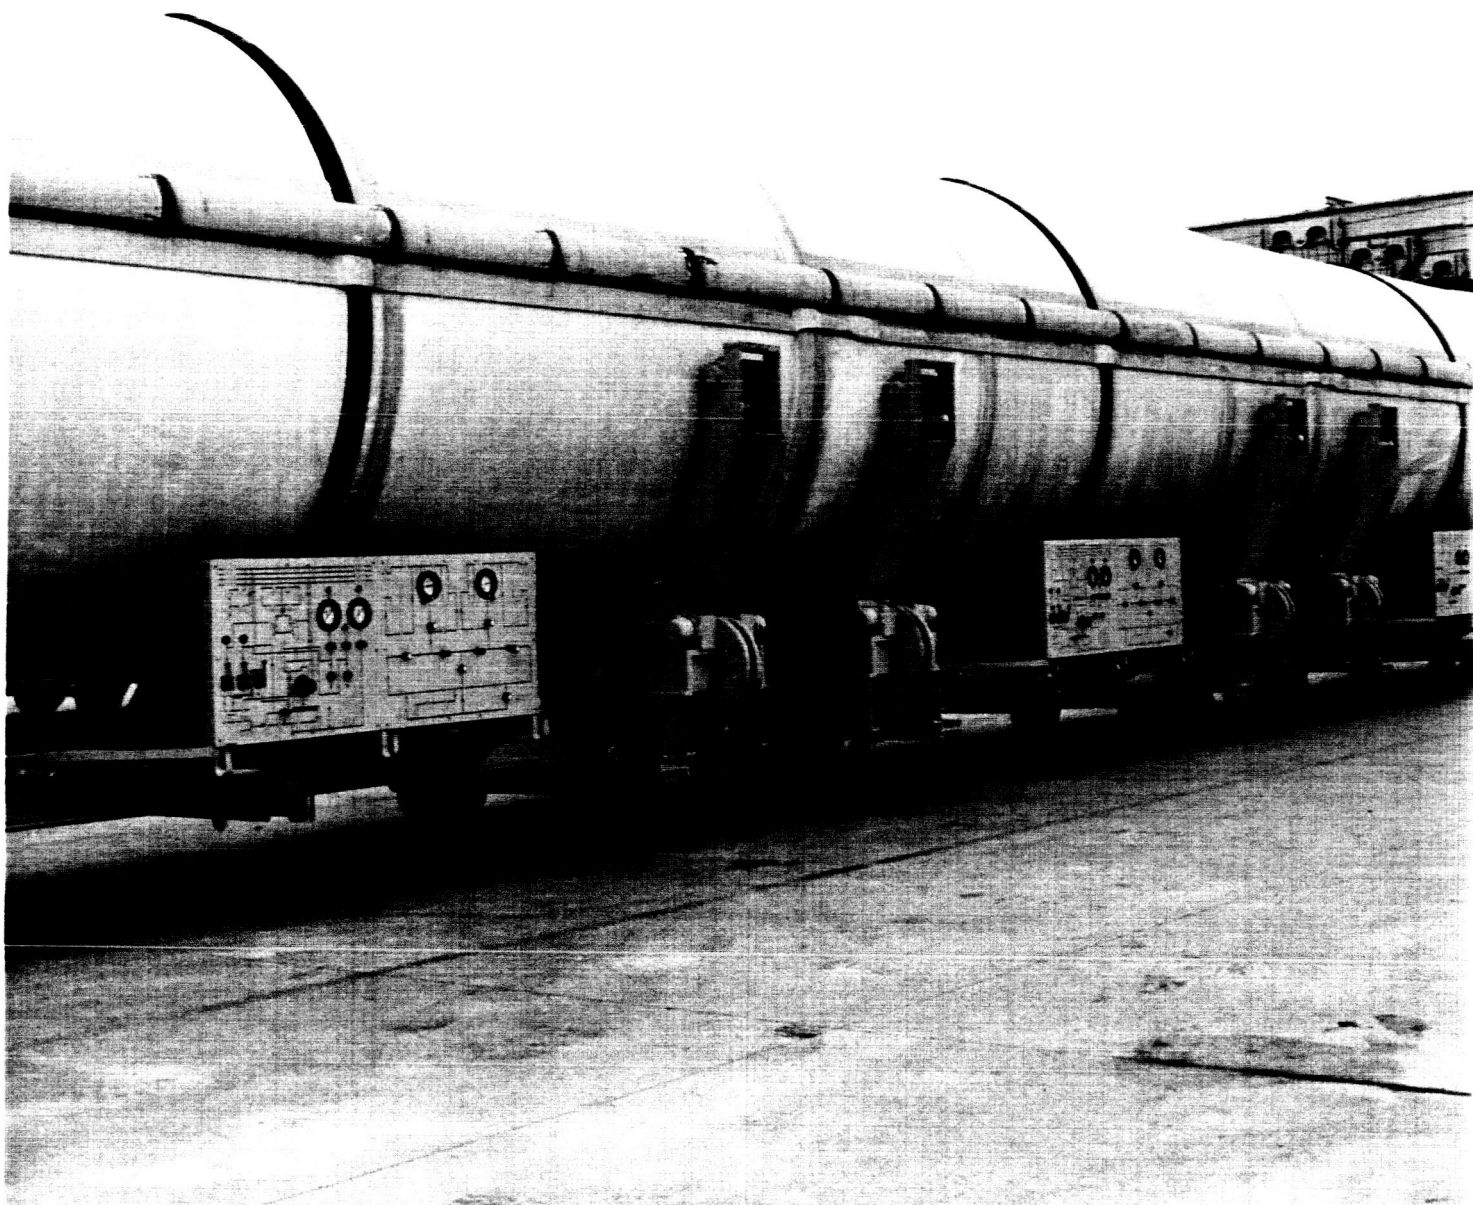
Overall view of the RH solid rocket motor. The field joint protection system closeouts were generally in good condition.

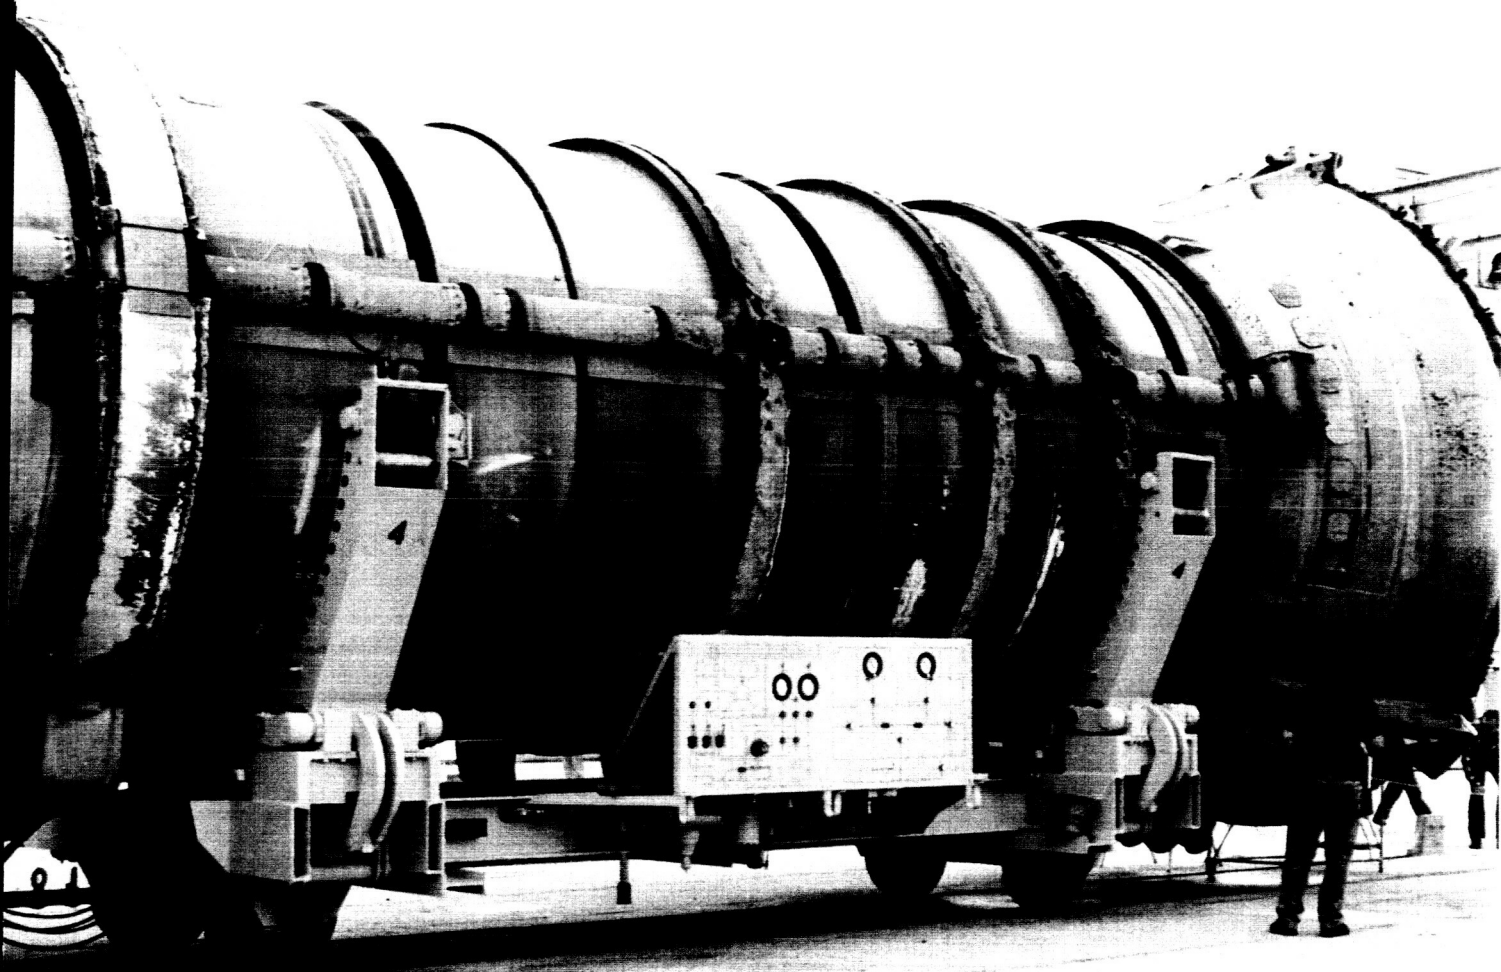
Post flight condition of the RH aft booster. The ET/SRB aft struts, ETA ring, IEA, and stiffener rings showed no unusual damage.

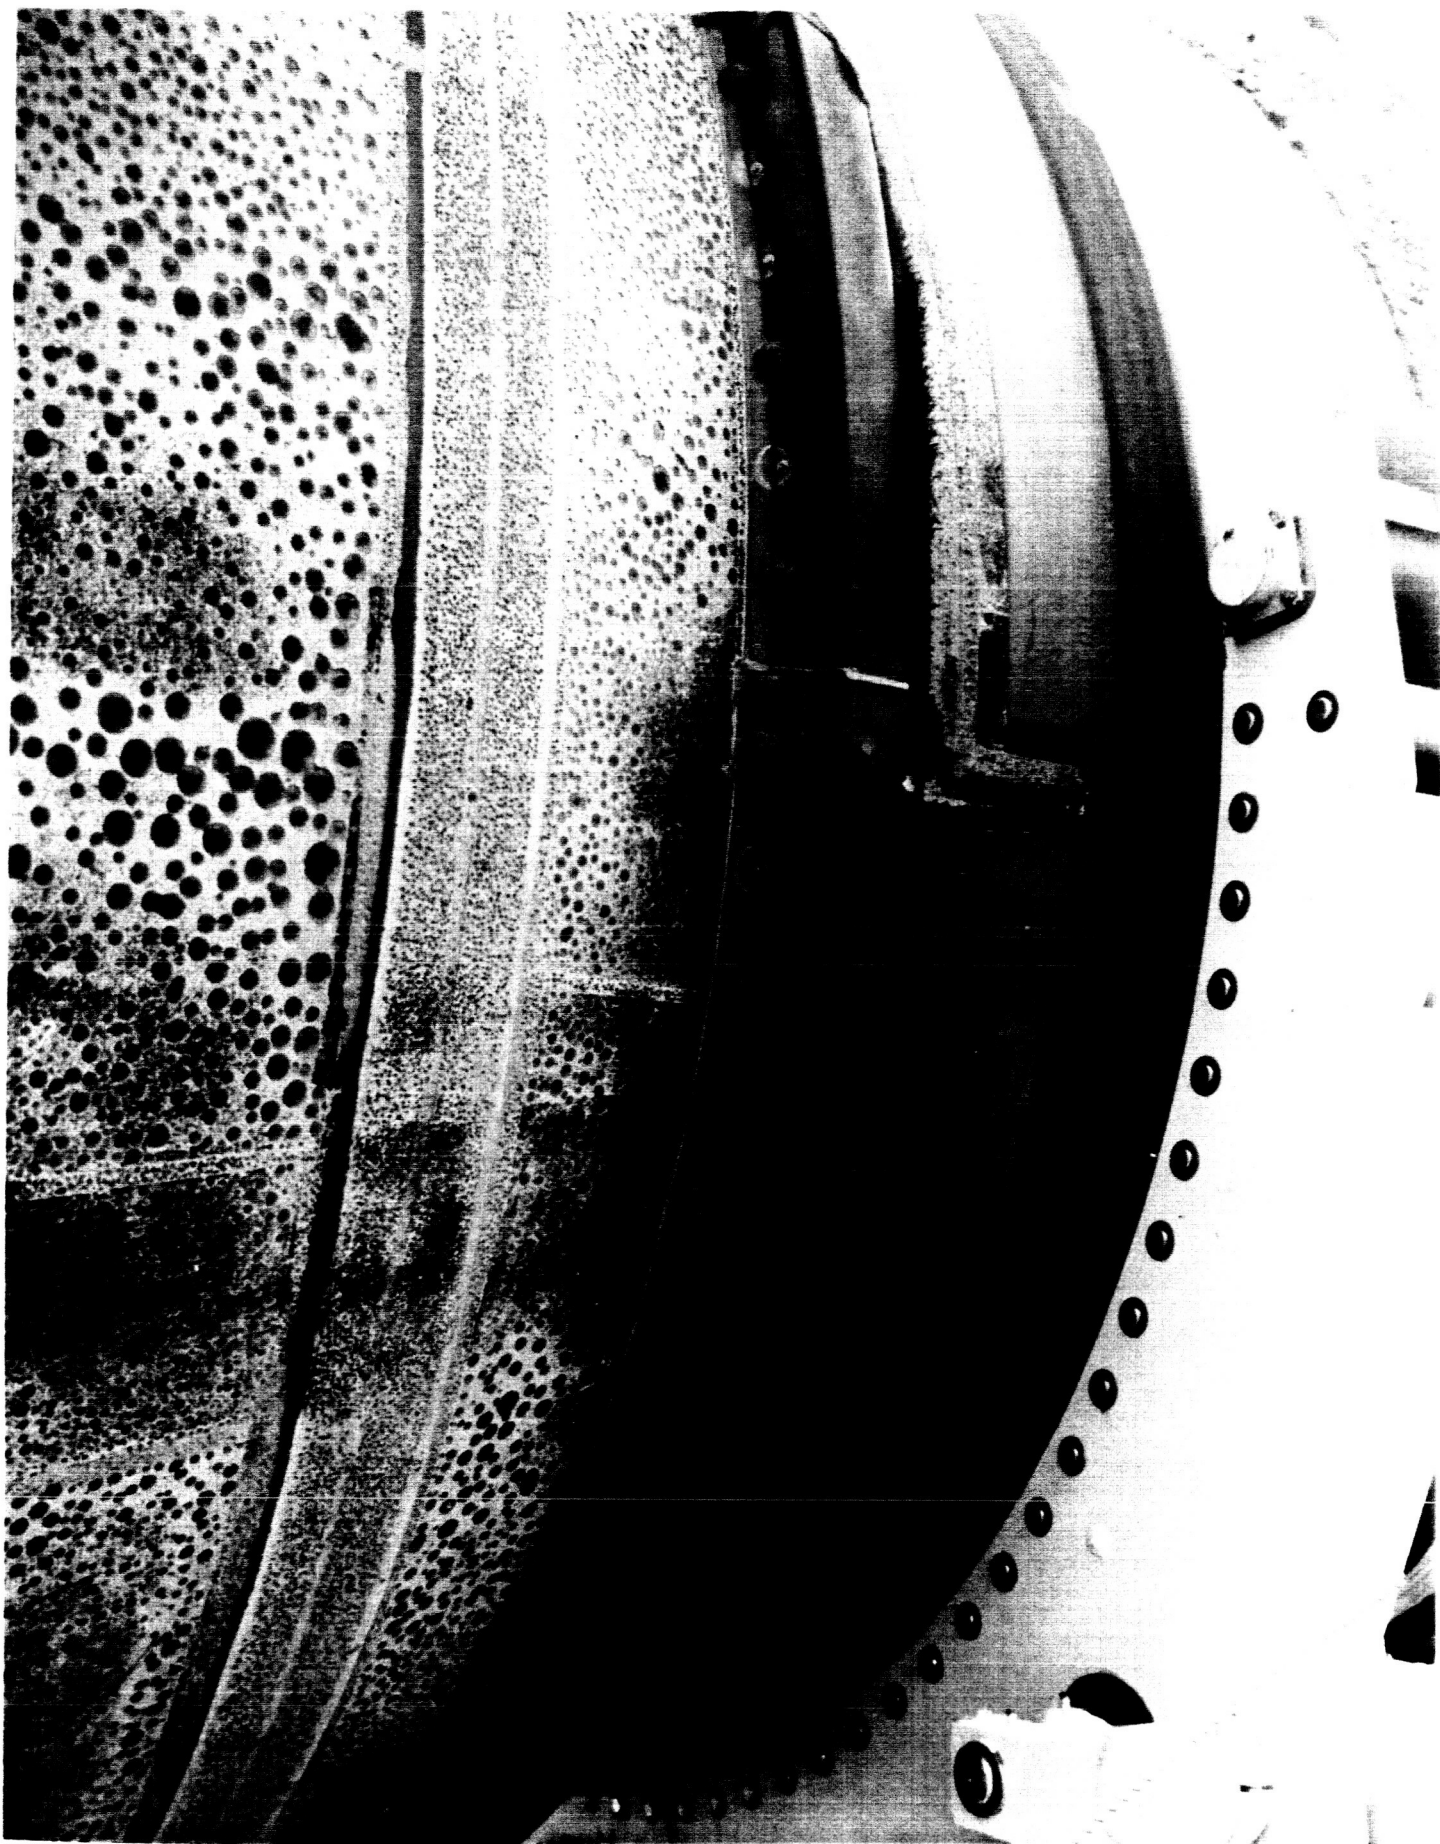
None of the K5NA protective domes on the aft side of the phenolic kick ring were missing prior to water impact

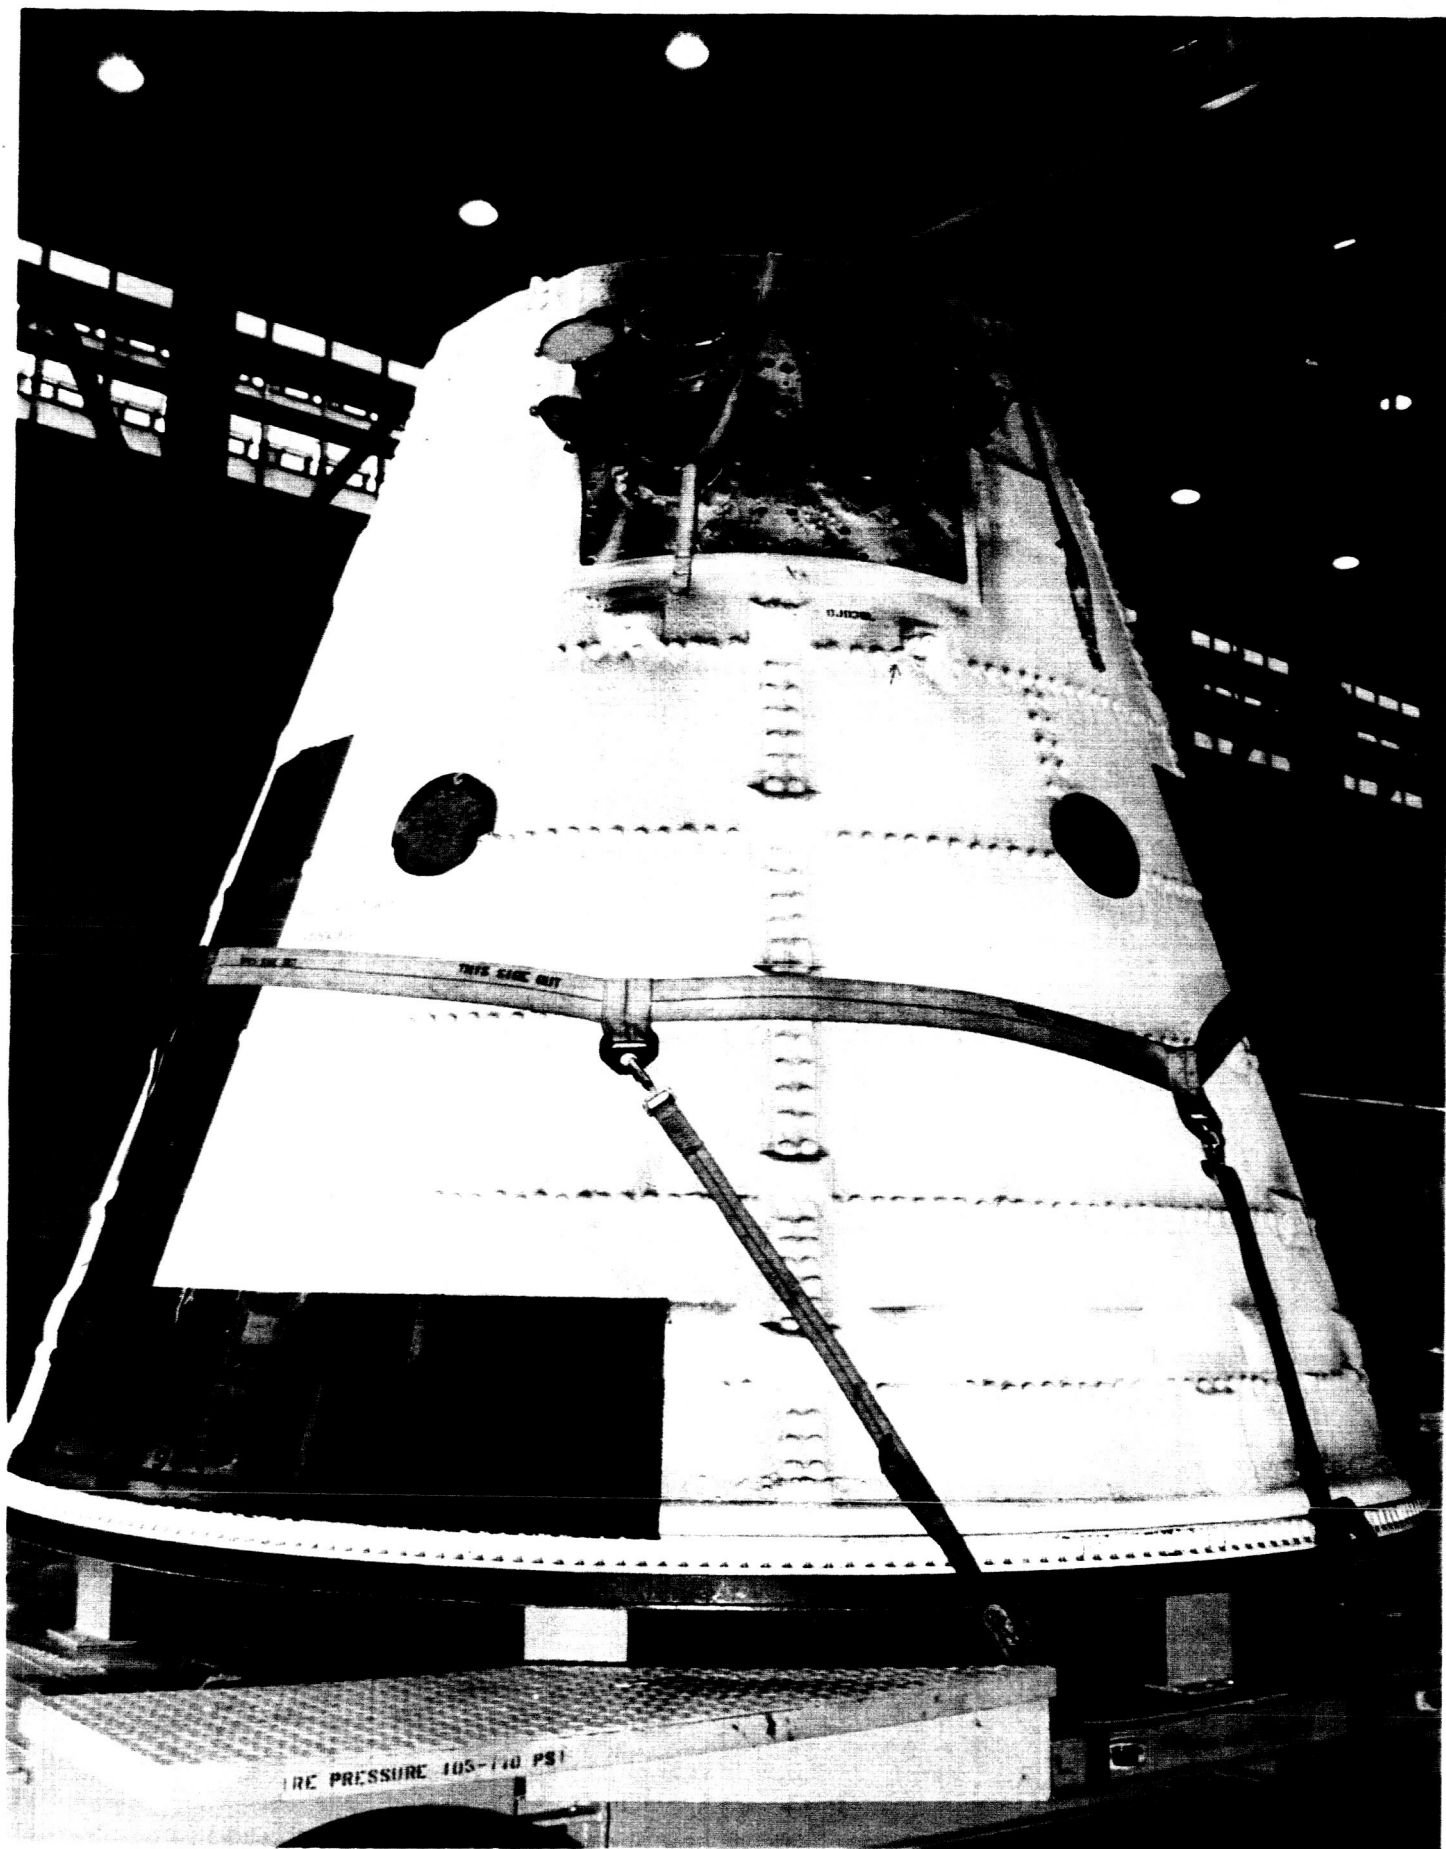
Post flight condition of the LH frustum. There were 21 MSA-2 debonds over fasteners, but no areas of missing TPS.

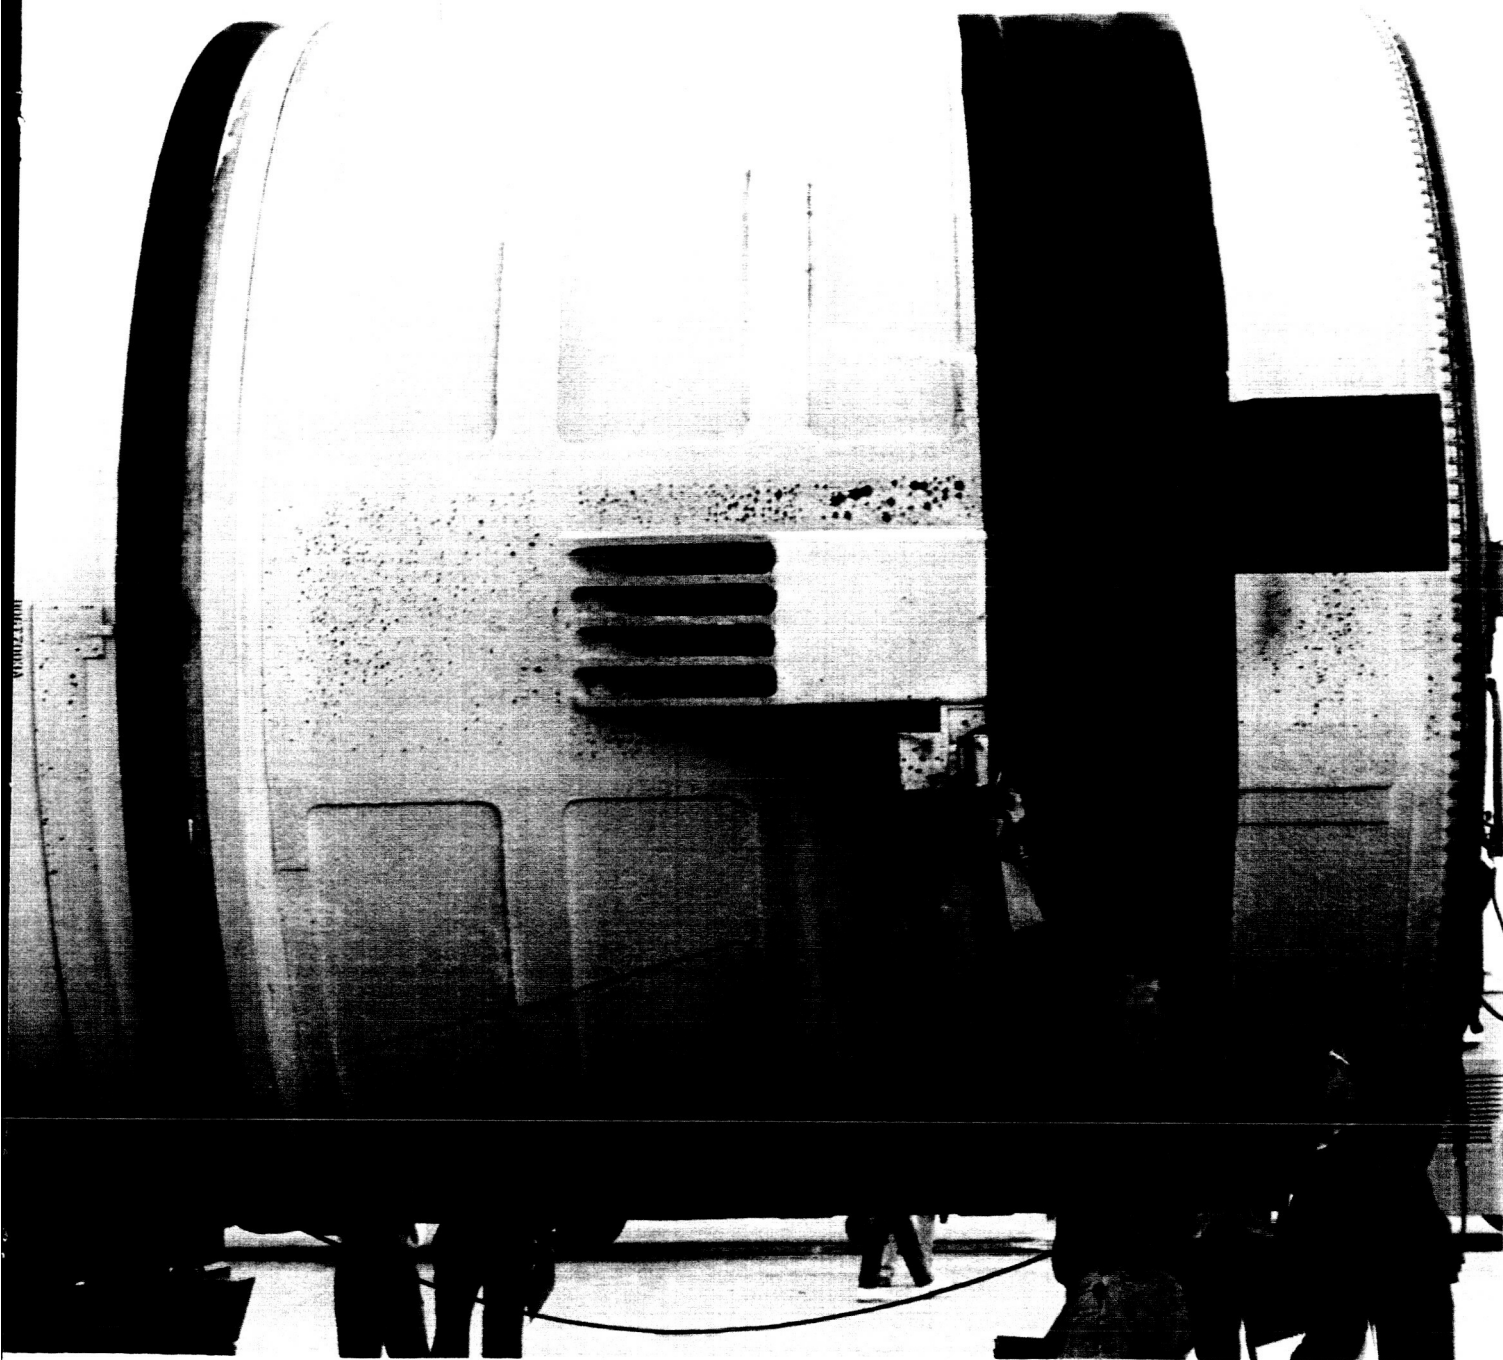
Post flight condition of the LH forward skirt. There were no
MSA-2 debonds or areas of missing TPS.

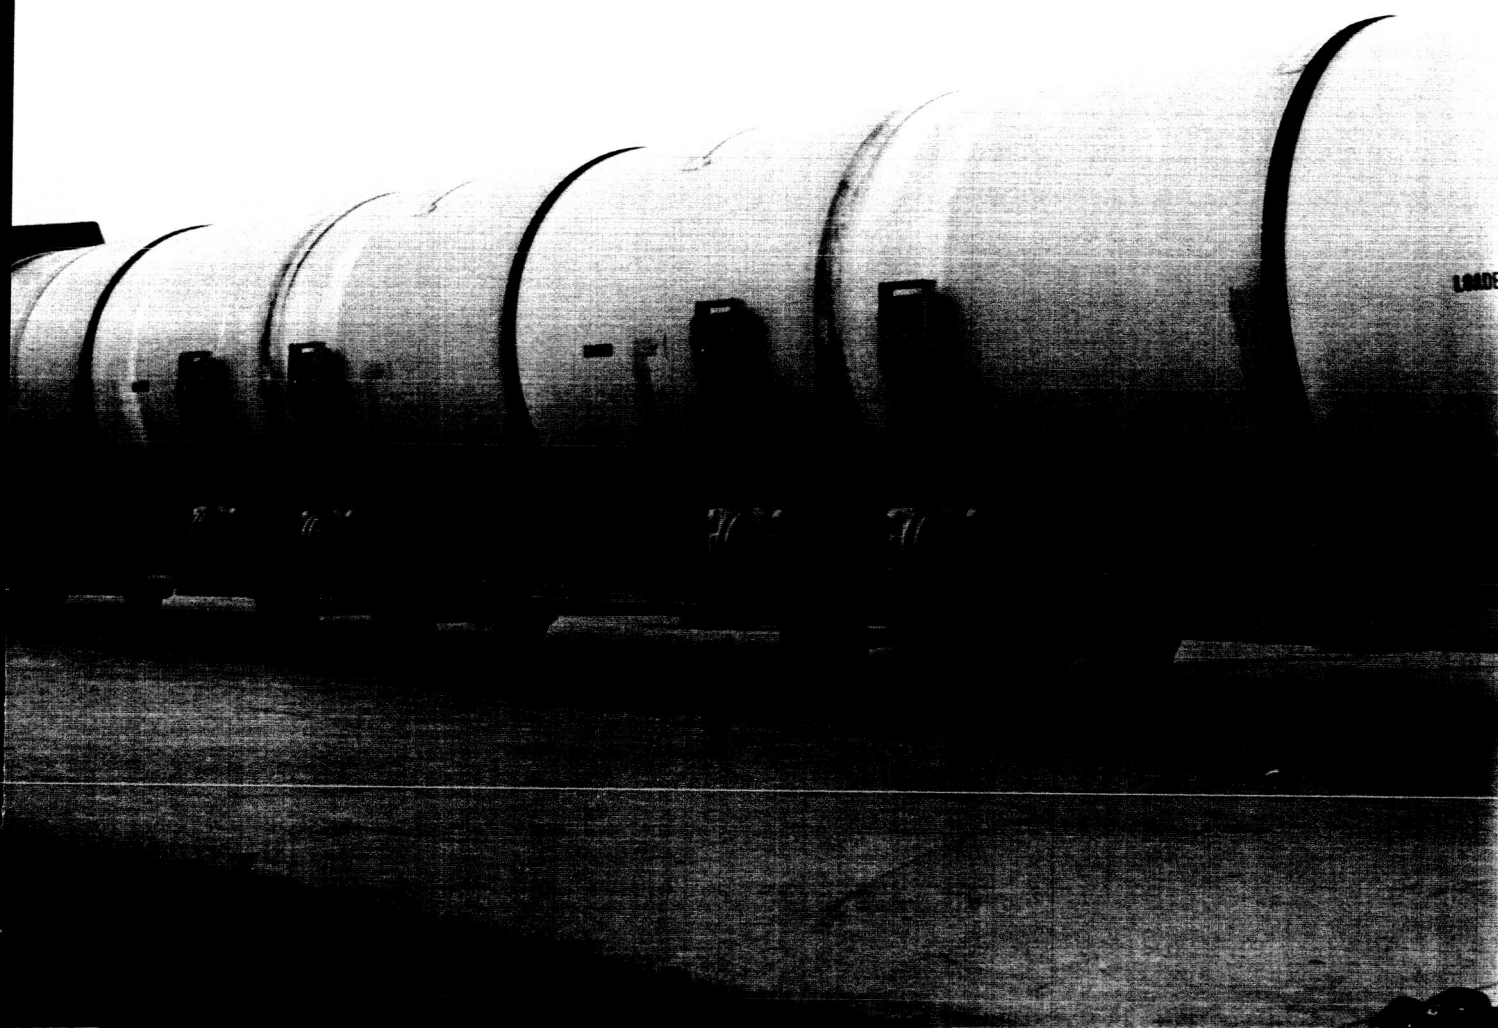
The field joint protection system closeouts on the LH solid rocket motor were generally in good condition

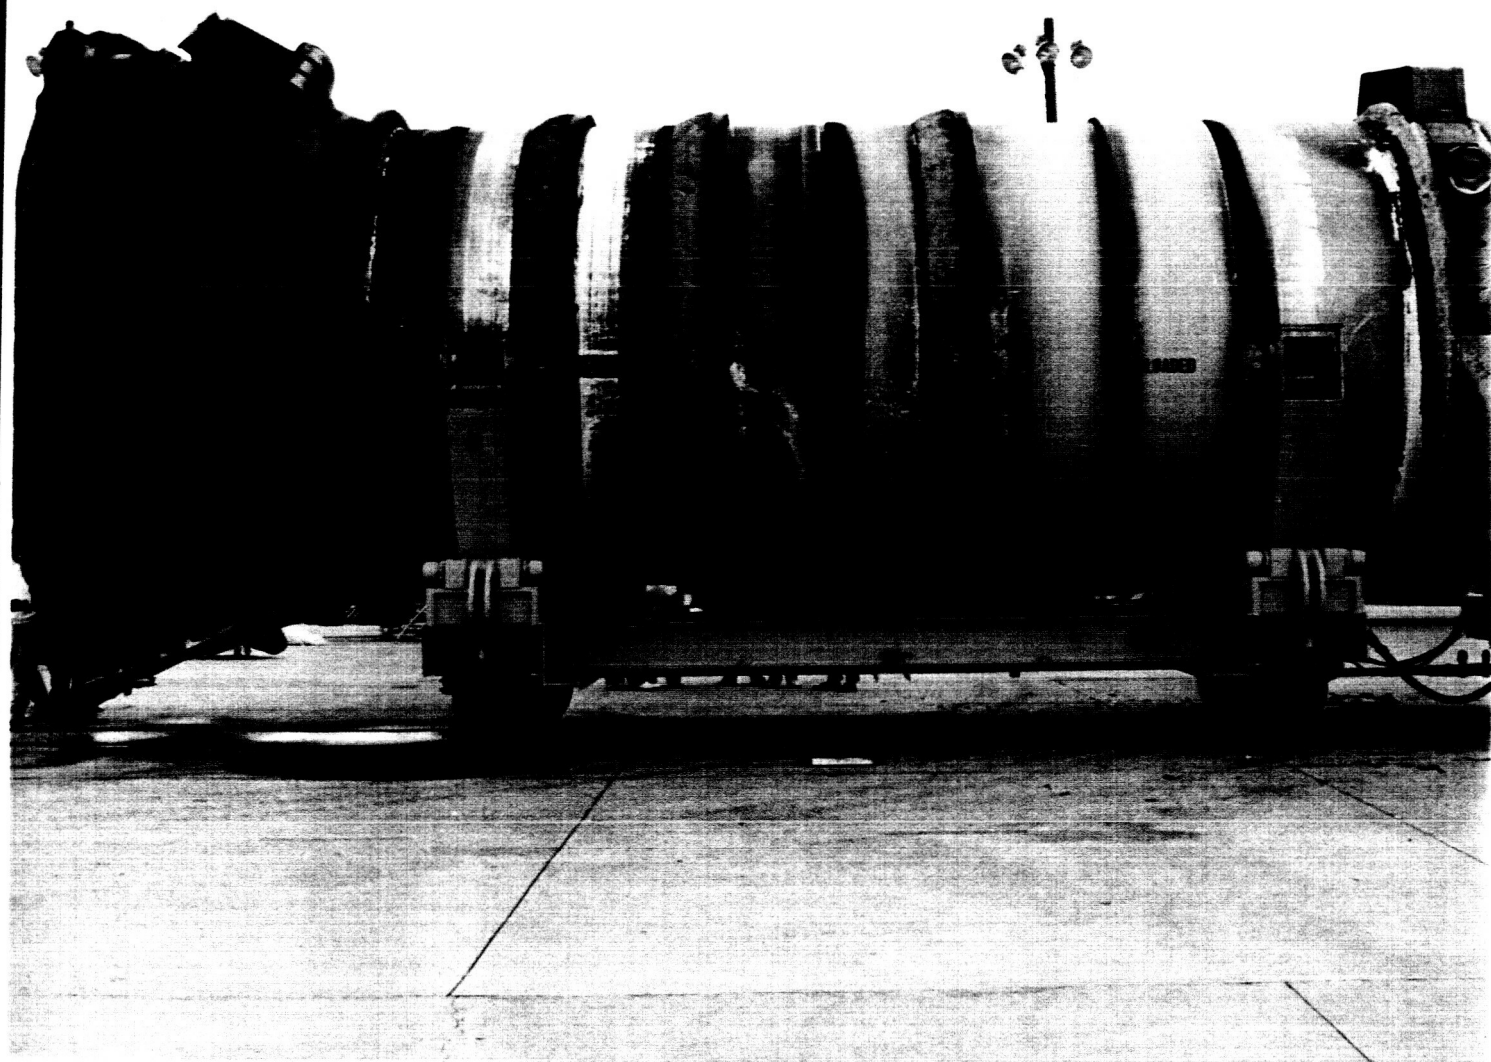
Post flight condition of the LH aft booster. The stiffener rings appeared undamaged after water impact.

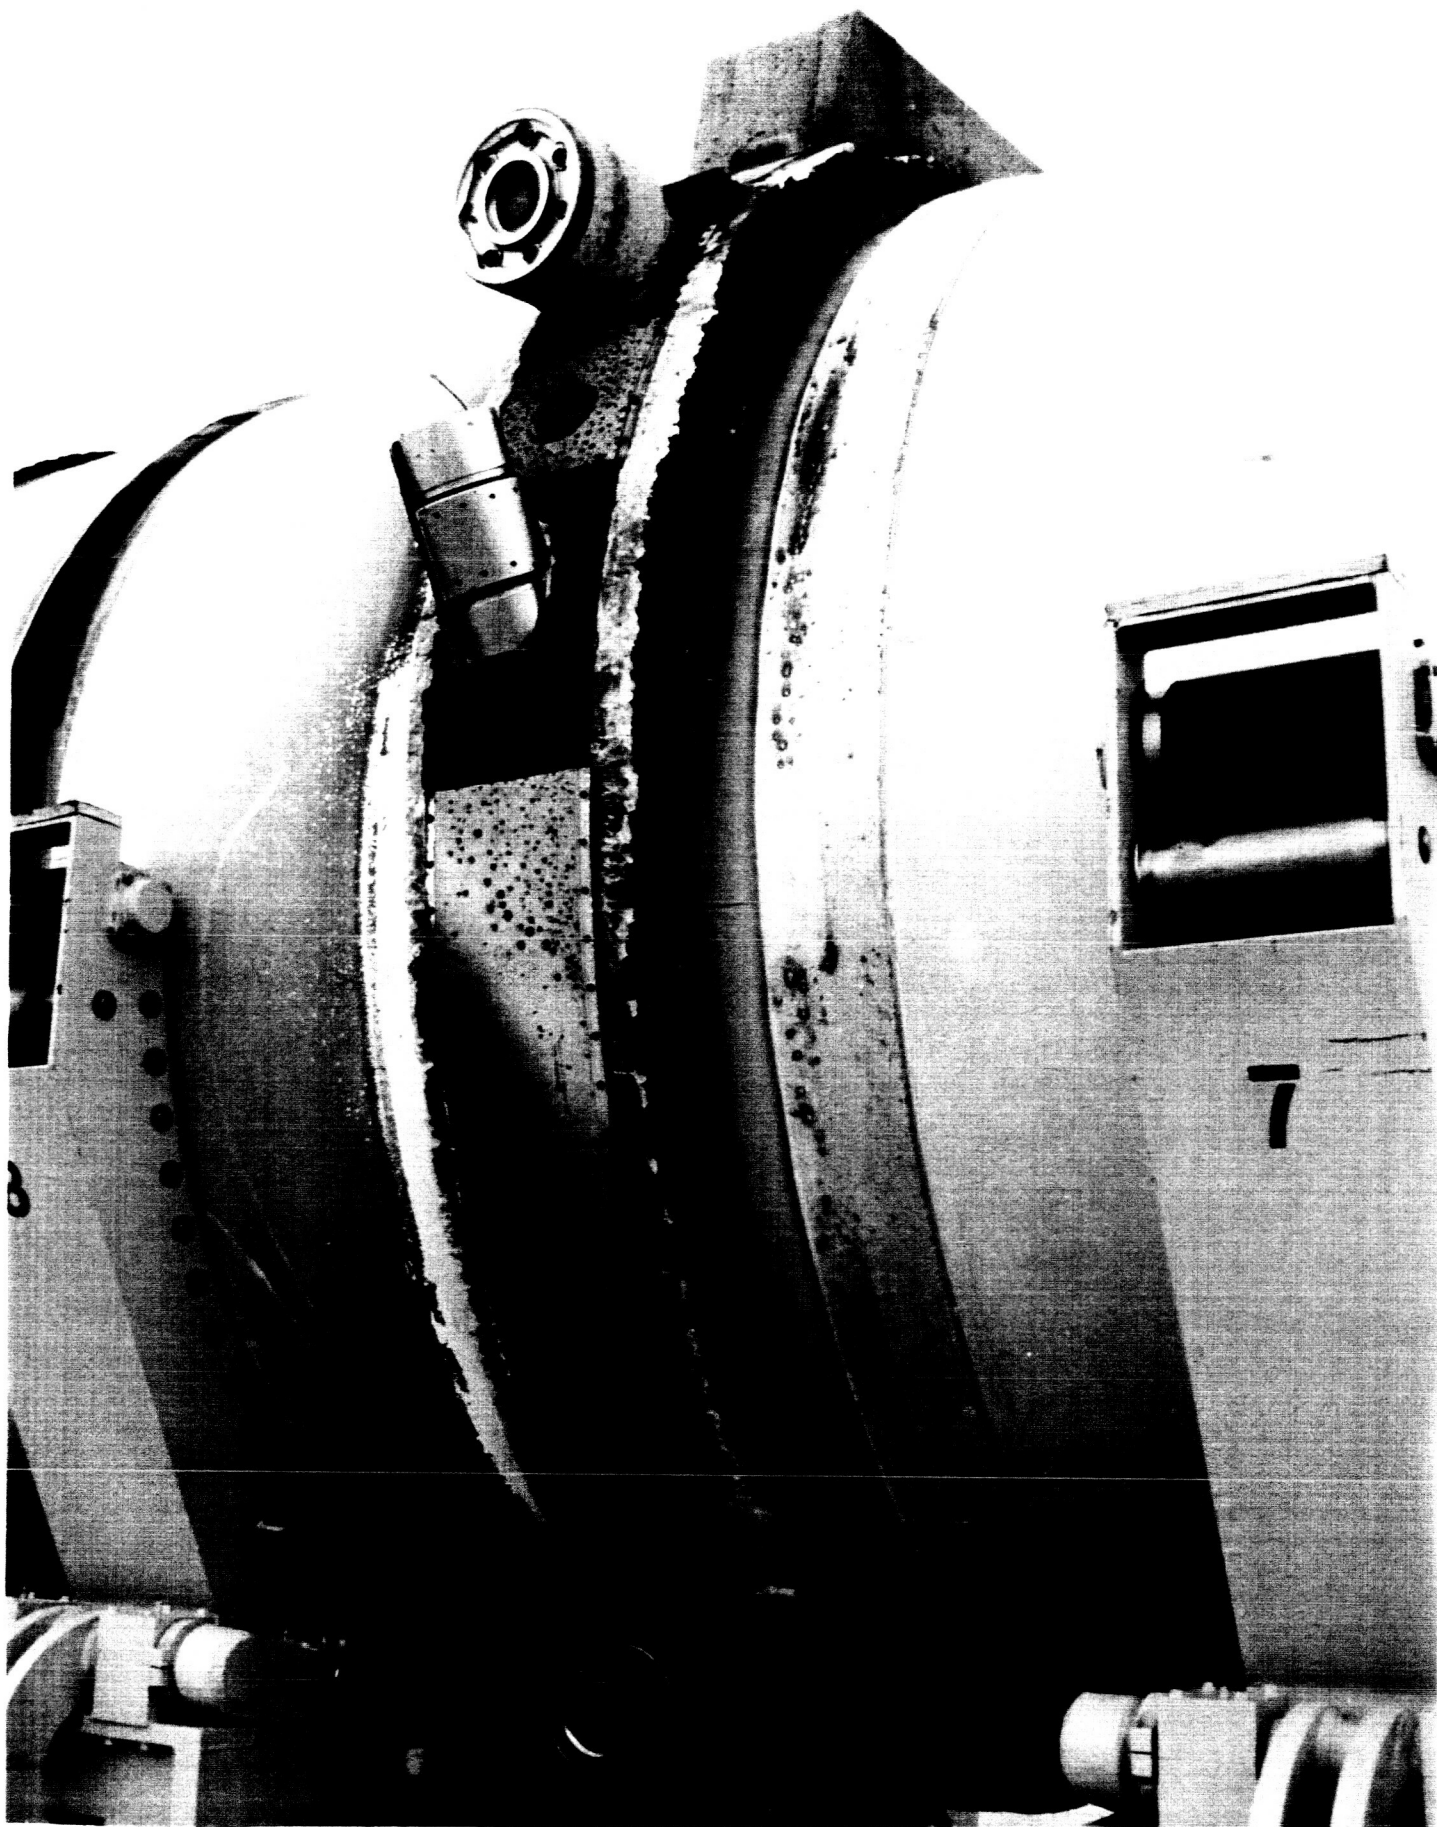
The ET/SRB struts, ETA ring, and IEA sustained no unusual damage during ascent and splashdown

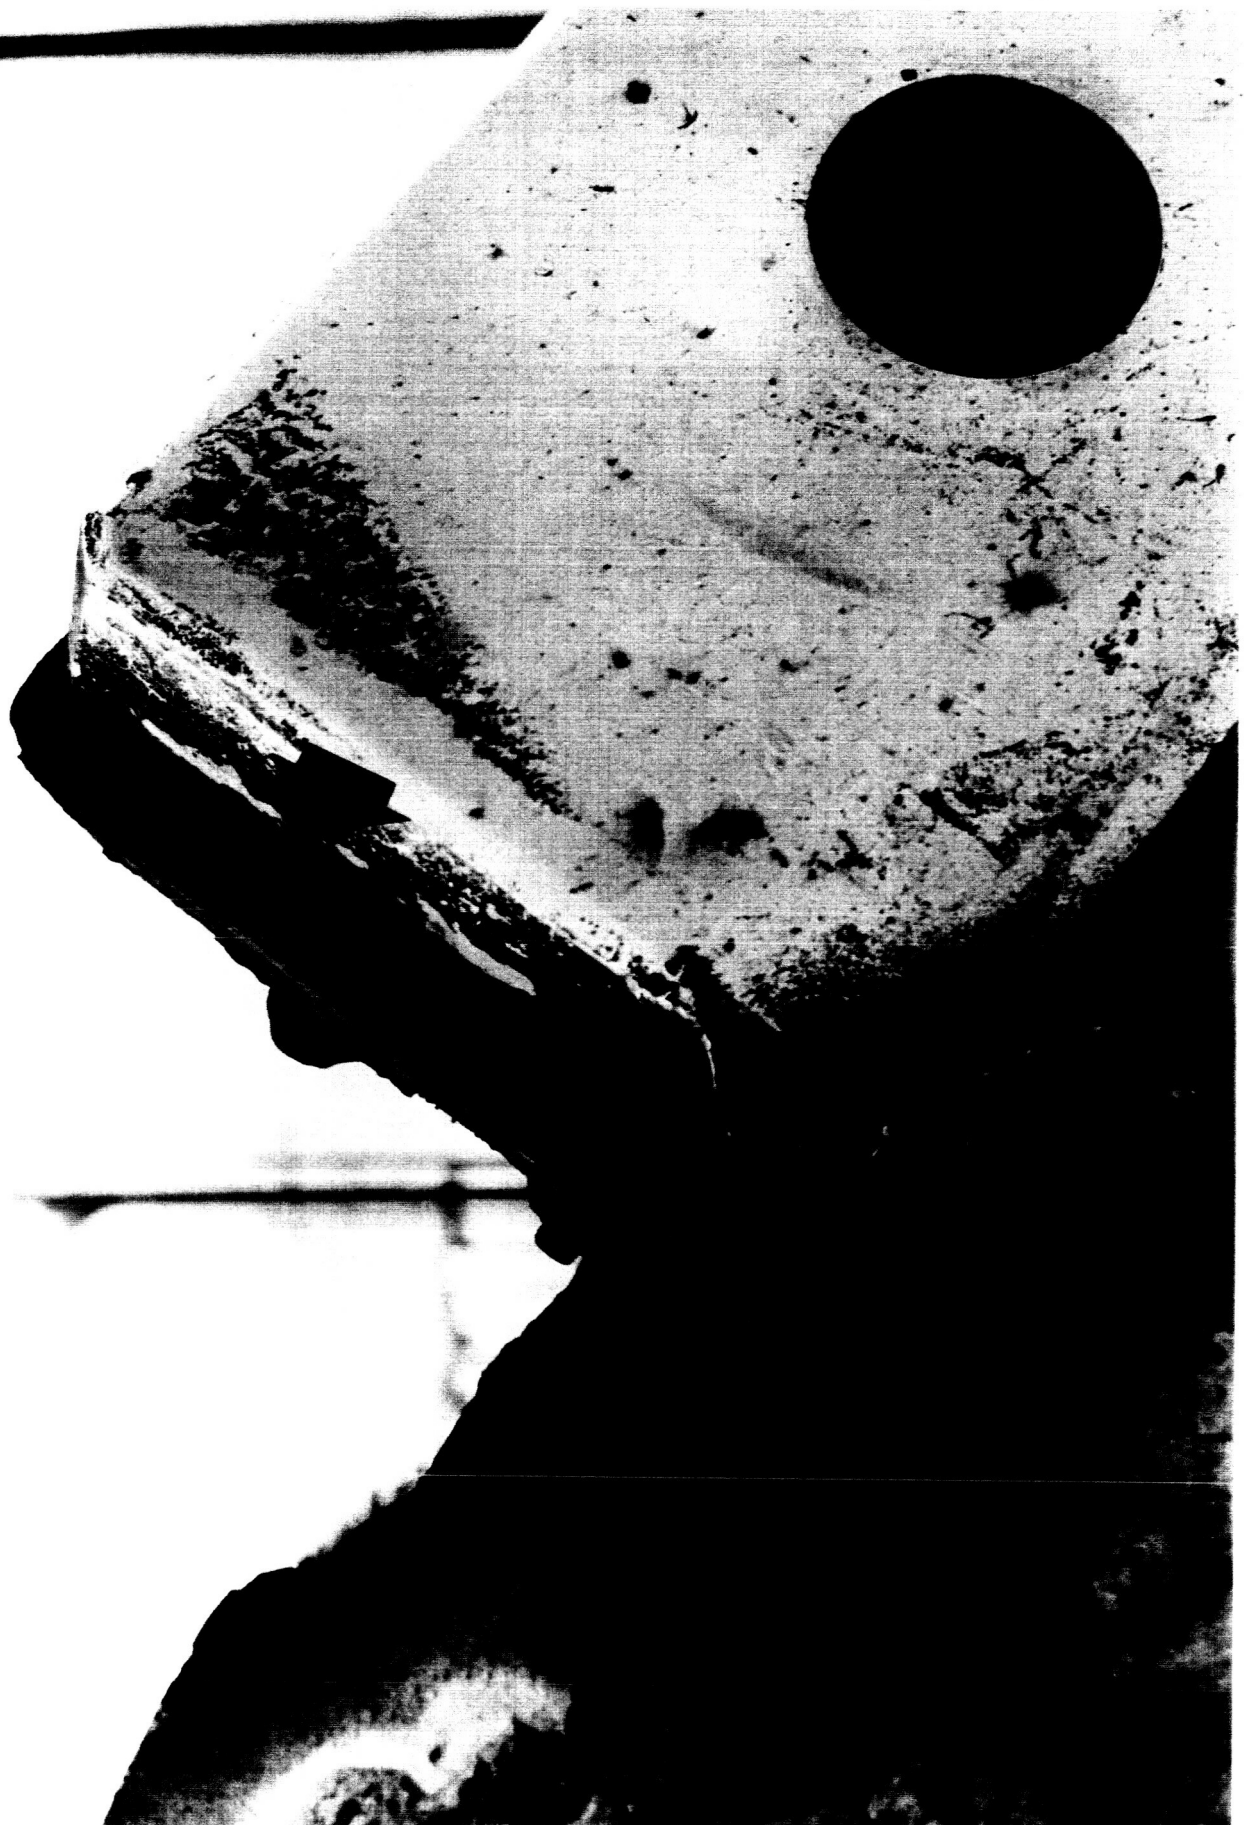
A 6"x0.5" piece of sidewall shim material, which should have remained bonded to the HDP #5 shoe, was found attached to the side of the aft skirt foot after retrieval.
